St Paul's Church  
Napier  
August 2011

#### CONDITION REPORT AND ESTIMATE COST

ARTIST: MAD.  
TITLE: St Paul's Church, Napier  
DATE: 1898  
MATERIAL: Oil on canvas  
DIMENSIONS: 462 x 312 mm

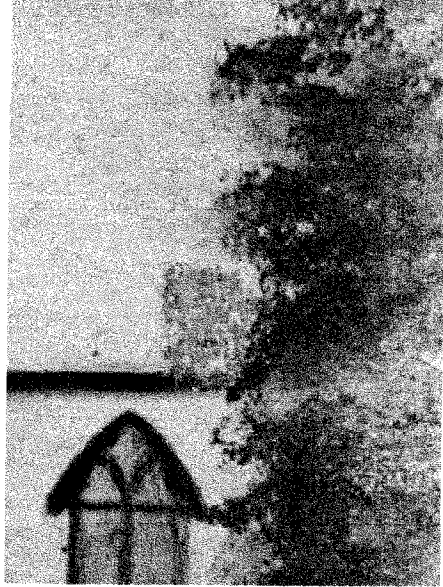
The oil painting represents St Paul's Church in Napier, with an elderly gentleman outside. The painting is signed and dated in the bottom left corner. The painting is framed in a decoratively carved wooden frame.

The painting is being held into the stretcher with metal tacks. Three keys of the stretcher are missing (one has fallen between the canvas and stretcher, causing a bulge in the canvas from the front). The bottom bar of the stretcher presents a split in the wood along the right side. The stretcher will need to be removed from its canvas to be restored and at this stage it is not possible to tell if it can be reused.

Overall the paint layer is very dirty and presents dust, fly spots and accretions. An oval shiny accretion is visible to the left of the figure of the man. The impression of the inside vertical edges of the stretcher bars are visible on the paint layer. A "T" shaped tear, with paint losses, is visible on the roof of the church. A patch had been applied to the rear of the tear in a past intervention, though it is no longer attached. A puncture hole, with paint loss, is visible in the top right corner of the sky. A matte circular indentation is visible to the right of the tower of the church. Two

scratches, with paint losses, are present along the right edge. Paint losses are visible around the edges of the painting where the paint layer has touched the frame.

- Removal of the painting from the frame
- Removal of the painting from the stretcher
- Dry clean of the rear of the canvas
- Flattening of the indentation and bulge
- First repair, thread by thread of the canvas
- Repair of the tear and puncture hole with application of canvas patches
- Re-tensioning of the painting onto either the cleaned old stretcher or new stretcher, keys in and secured
- Surface clean of the paint layer
- Filling of the paint losses
- Retouching of the paint losses
- Application of varnish
- Remounting of the painting into its frame
- Application of a backing
